**REMEDIAL ACTION COMPLETION REPORT**

**A PORTION OF WILLOW STREET STATION  
CHICAGO, ILLINOIS**

**THE PEOPLES GAS  
LIGHT and COKE COMPANY**

**PROJECT NO. 28020**

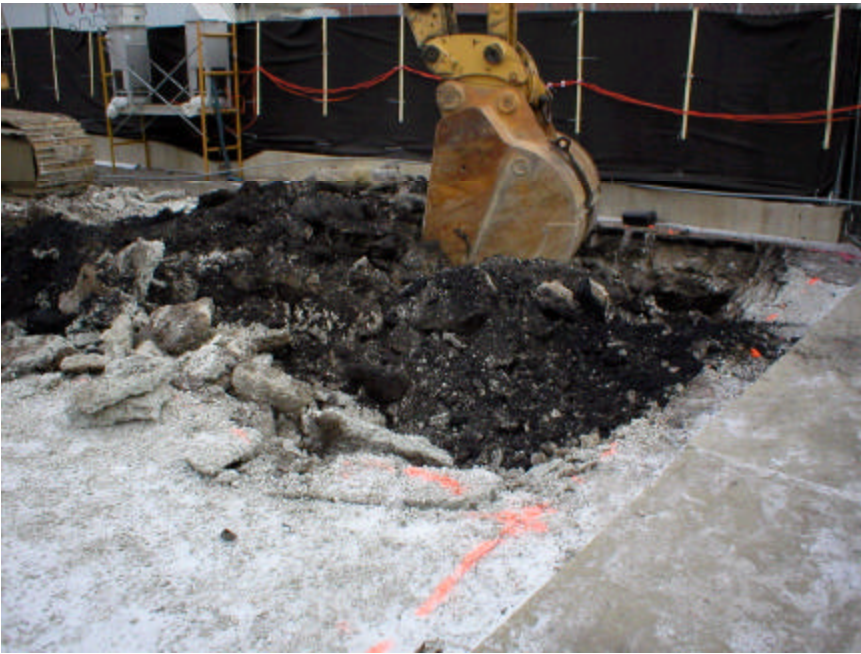
A Portion of Willow Street Station  
Date: January 20, 2003

Excavation of surface soil in cell 1 located in the southeast corner of the Site.

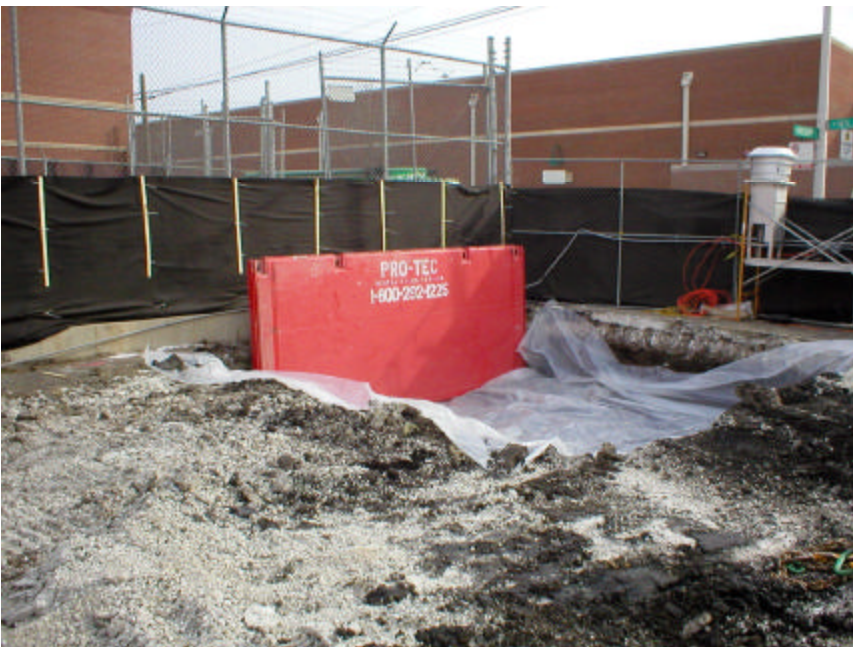
A Portion of Willow Street Station  
Date: January 20, 2003

East panel of shoring system installed in cell 1. Plastic liner placed over excavation to limit odors.

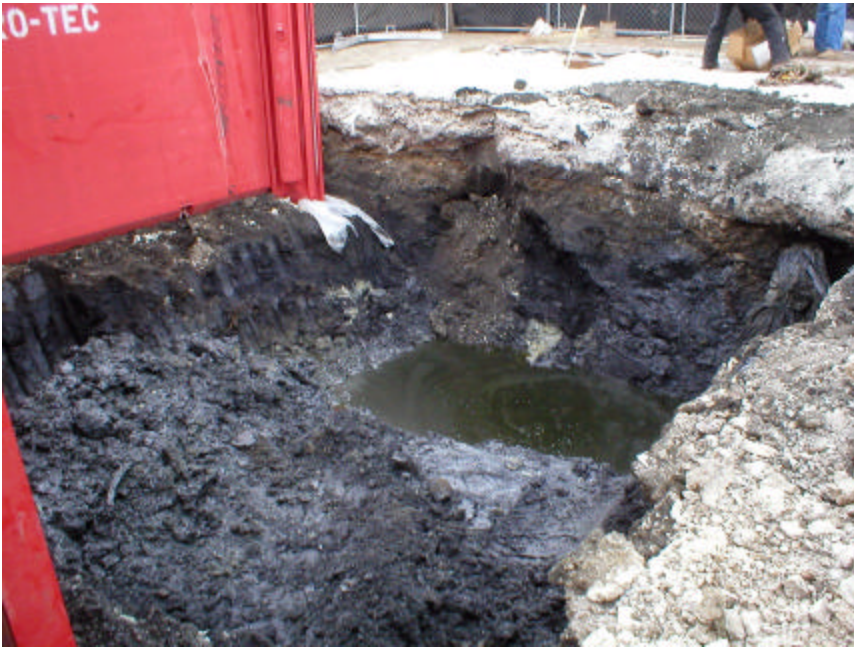
A Portion of Willow Street Station  
Date: June 20, 2003

View 3-foot excavation in cell 1 with east and south panels of shoring system installed. Visual impacts observed in soil and water from broken pipe.

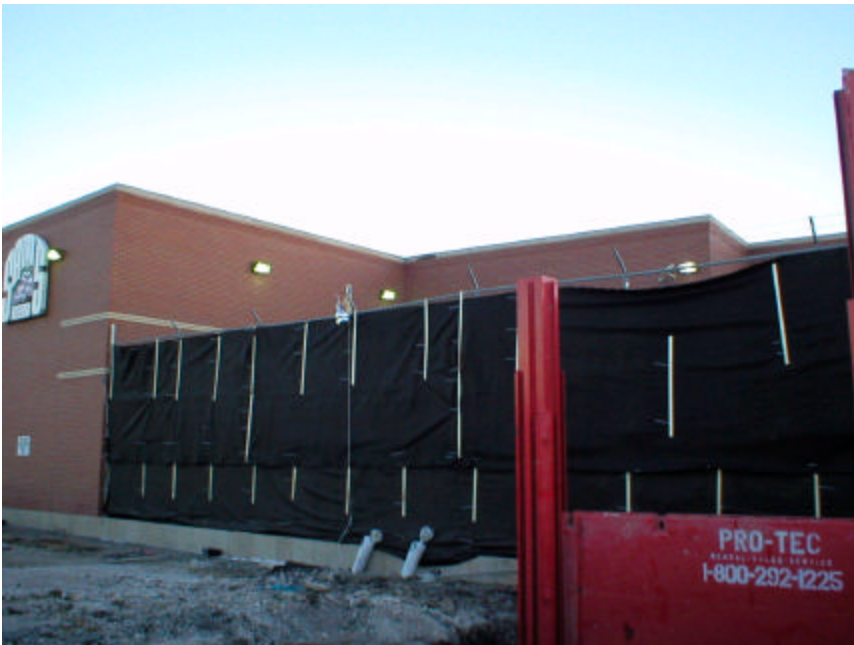
A Portion of Willow Street Station  
Date: January 20, 2003

View of silt fabric on fence next to the loading dock outside northeastern property boundary.

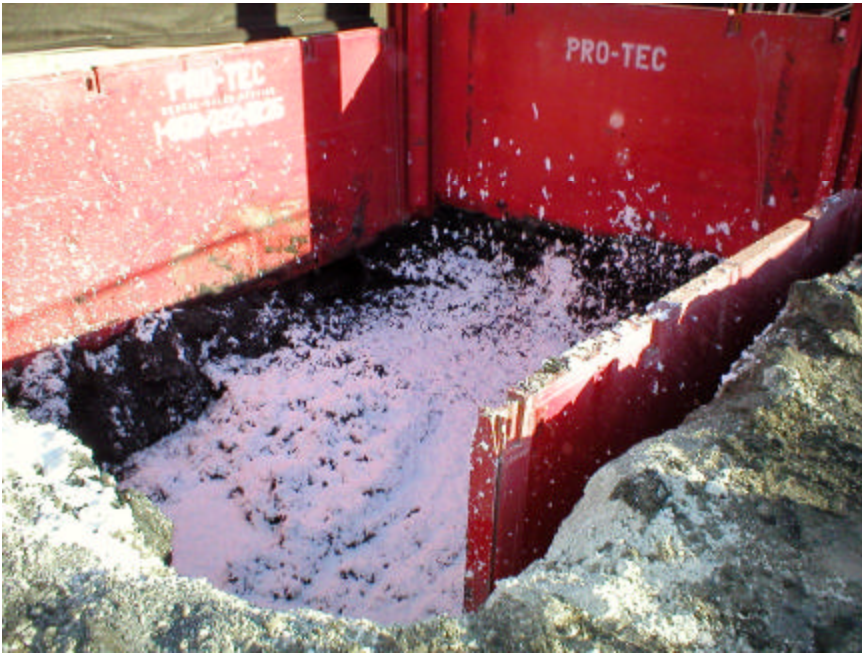
A Portion of Willow Street Station  
Date: January 21, 2003

View of excavation in cell 1 after foaming. South, east and west panels of shoring system installed.

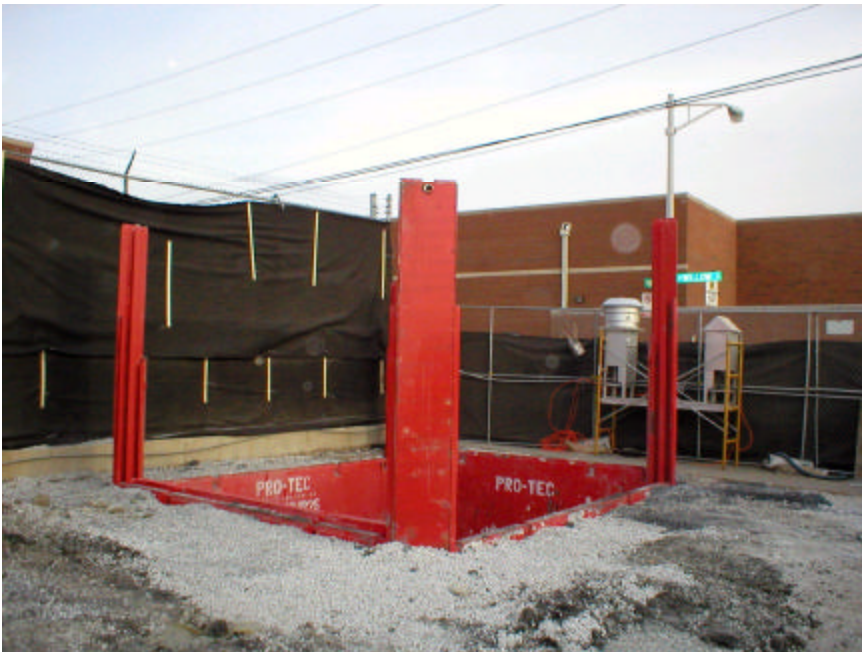
A Portion of Willow Street Station  
Date: January 22, 2003

View of installed shoring system in cell 1.

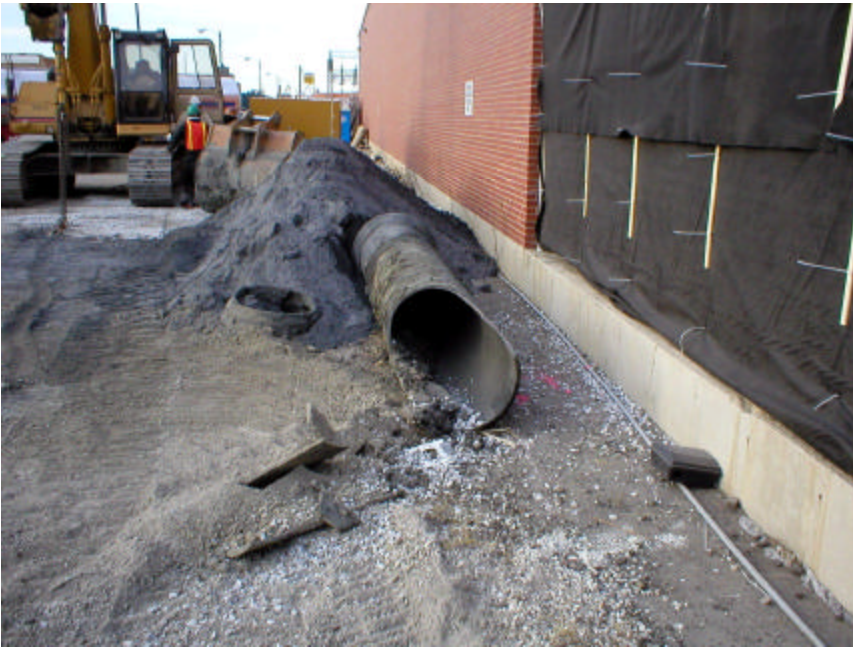
A Portion of Willow Street Station  
Date: January 22, 2003

View of 24"-diameter cast-iron pipe removed during excavation of cell 1.

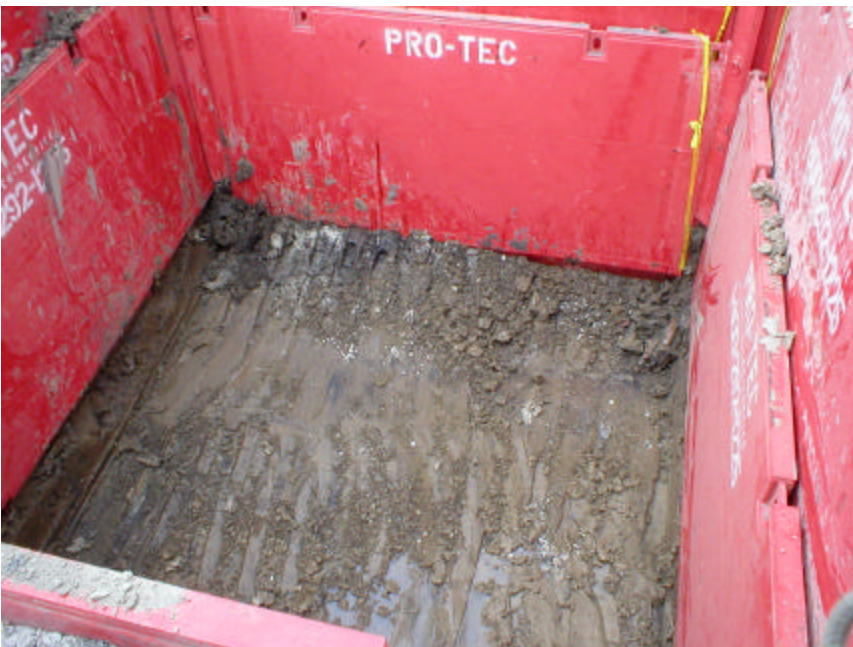
A Portion of Willow Street Station  
Date: January 24, 2003

View of visually clean native clay bottom of cell 1 at 12 feet bgs.

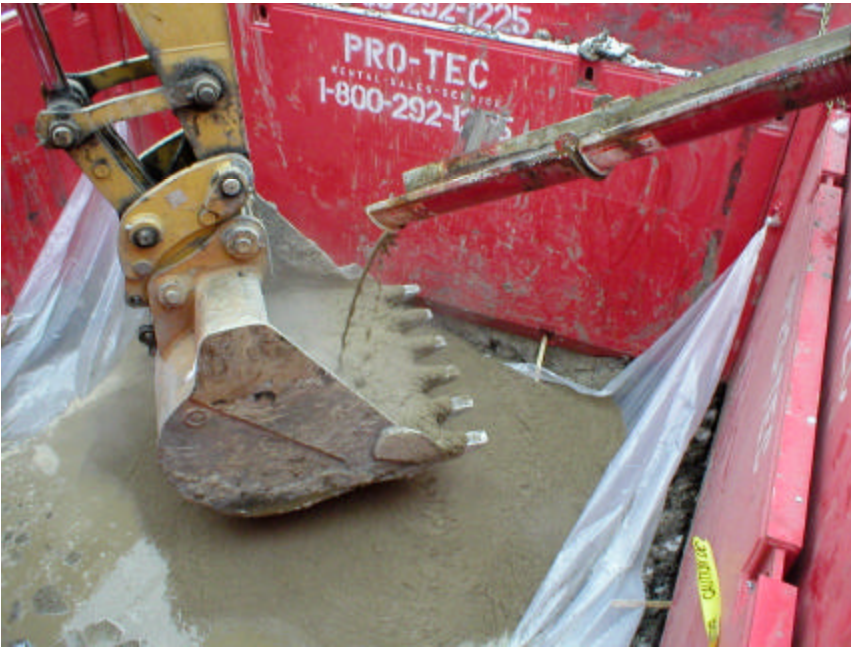
A Portion of Willow Street Station  
Date: January 27, 2003

View of first flowable grout pour in cell 1.

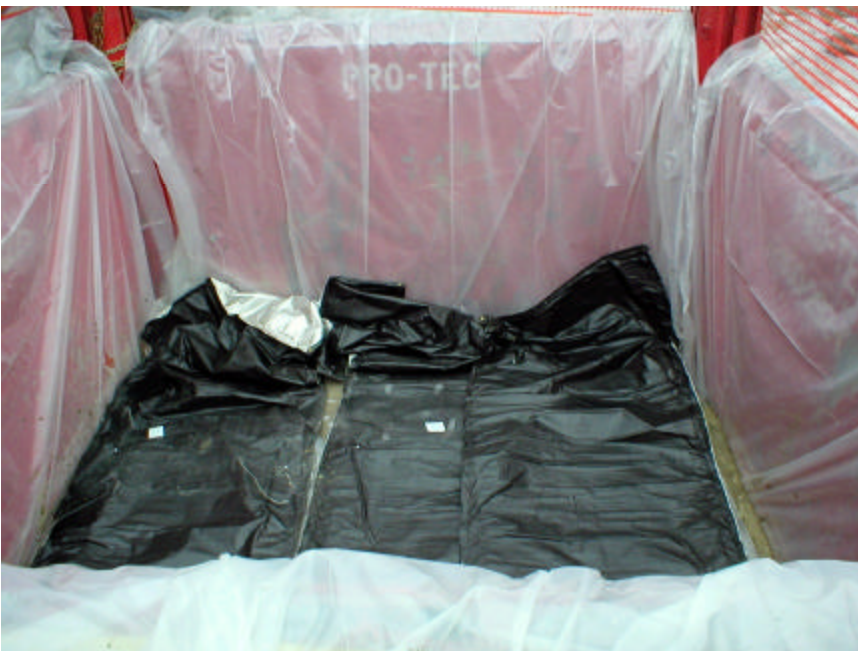
A Portion of Willow Street Station  
Date: January 27, 2003

View of concrete blankets placed on top of curing grout in cell 1 overnight.

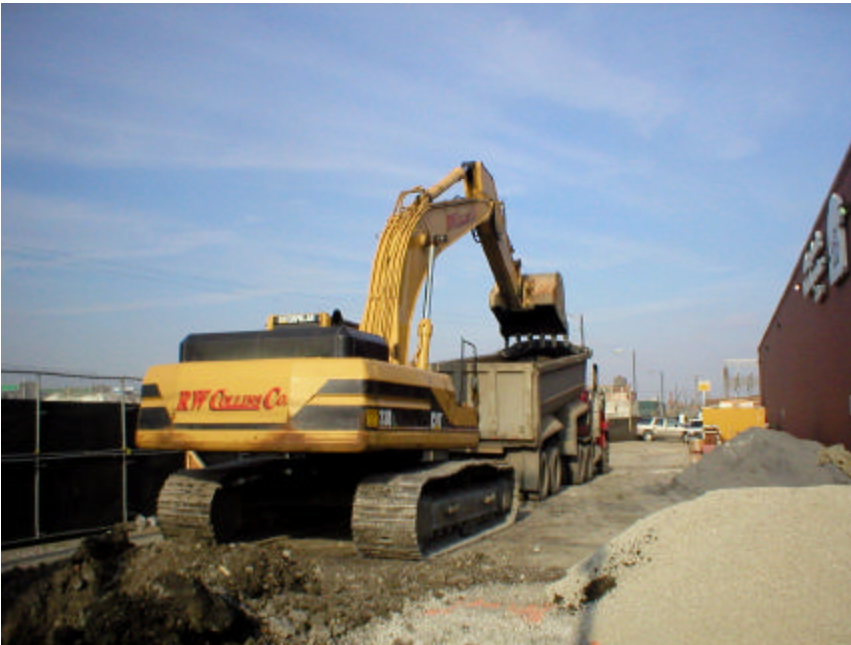
A Portion of Willow Street Station  
Date: February 6, 2003

View of excavator direct-loading soil excavated from cell 2 for offsite disposal.

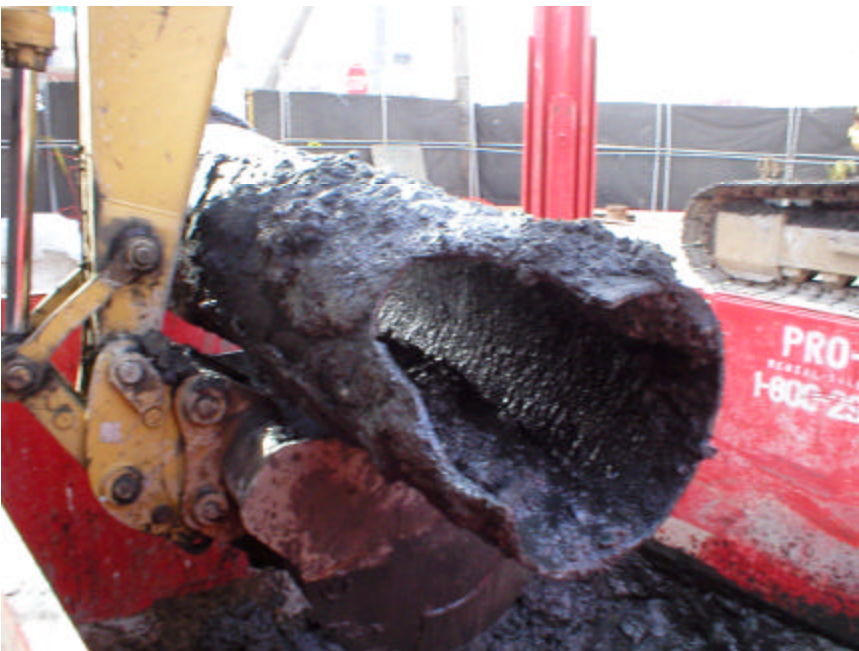
A Portion of Willow Street Station  
Date: February 21, 2003

View of former MGP 36"-diameter pipe removed from cell 3.

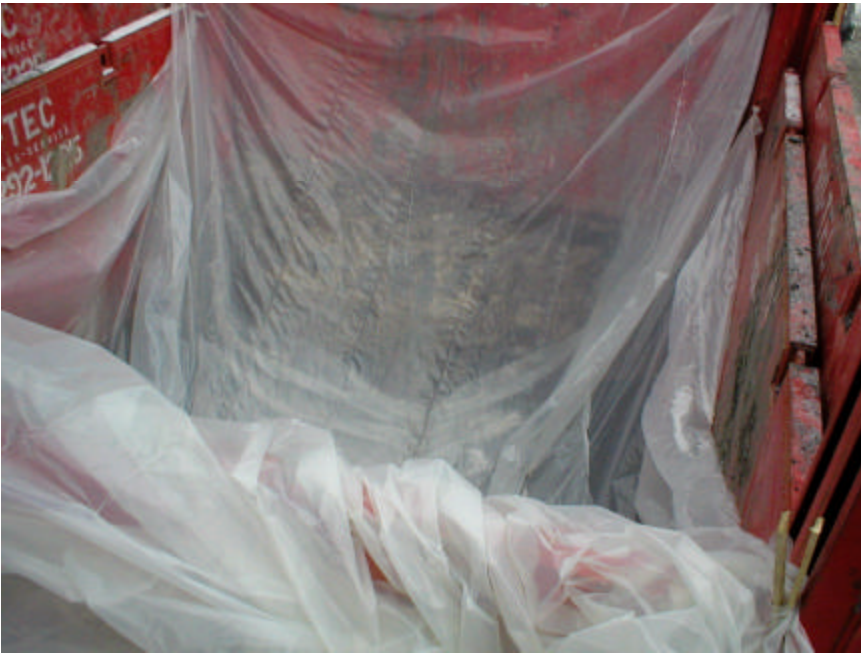
A Portion of Willow Street Station  
Date: February 24, 2003

View of former plastic lining placed in cell 3 prior to backfill with flowable grout.

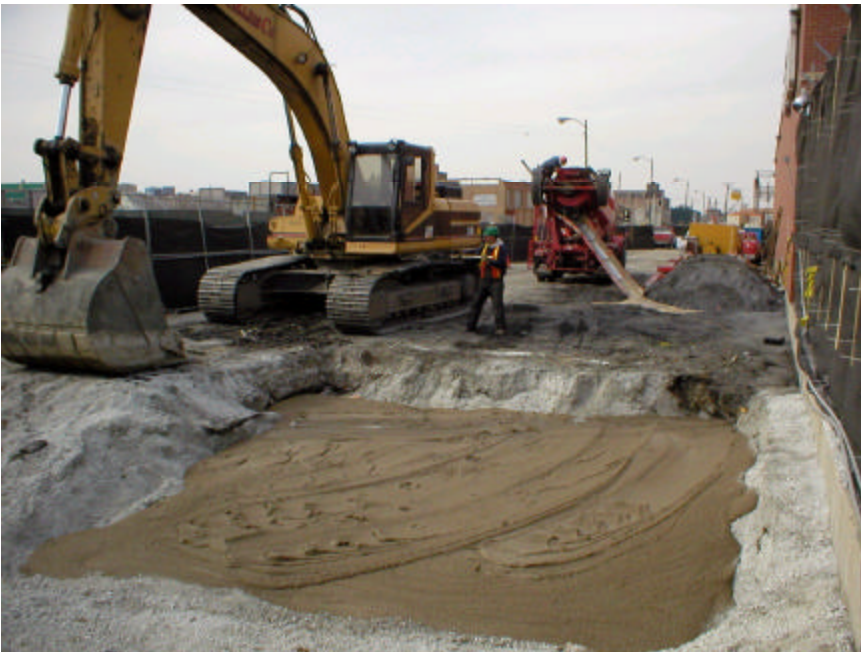
A Portion of Willow Street Station  
Date: February 28, 2003

View of cell 3 backfilled to 2 feet bgs after removal of shoring system.

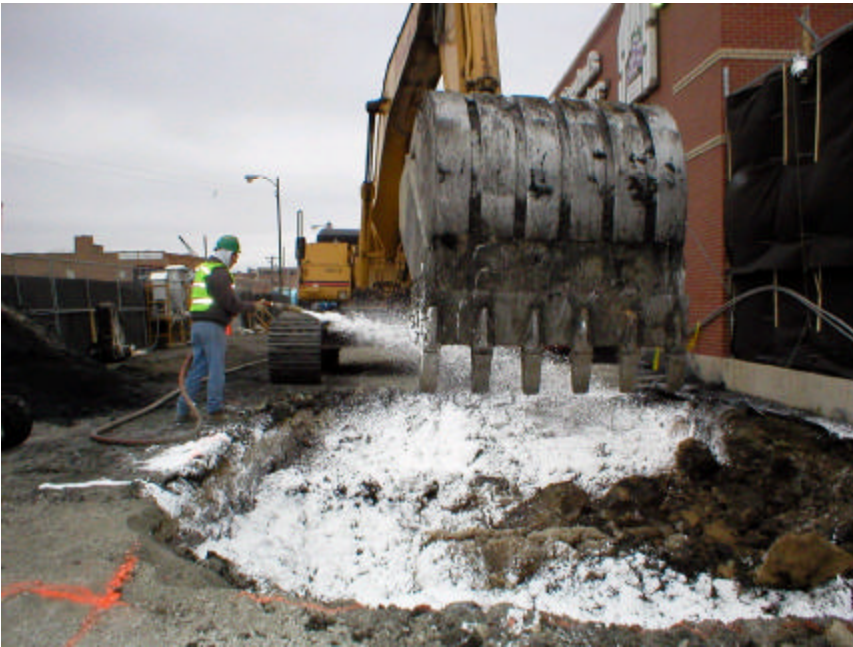
A Portion of Willow Street Station  
Date: March 13, 2003

View of foaming during excavation of surface soil in cell 5.

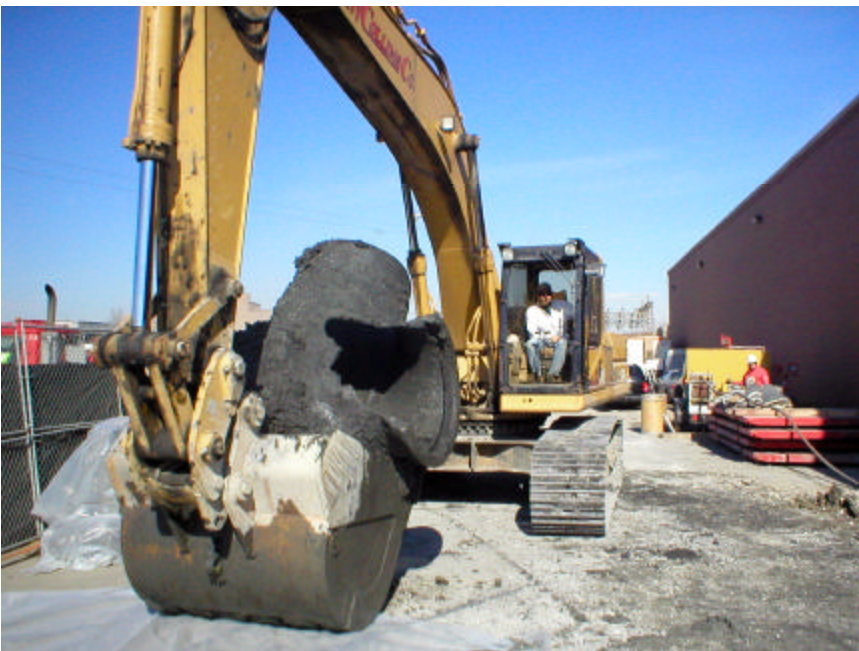
A Portion of Willow Street Station  
Date: March 14, 2003

View of MGP pipe removed during excavation of cell 5.

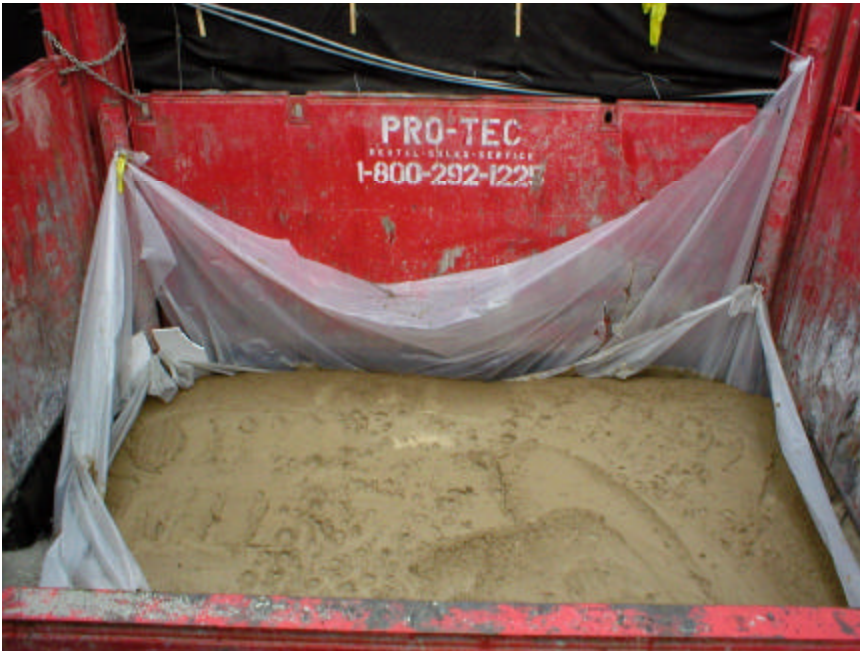
A Portion of Willow Street Station  
Date: March 19, 2003

View of backfilled cell 5 lined with plastic to prevent potential migration.

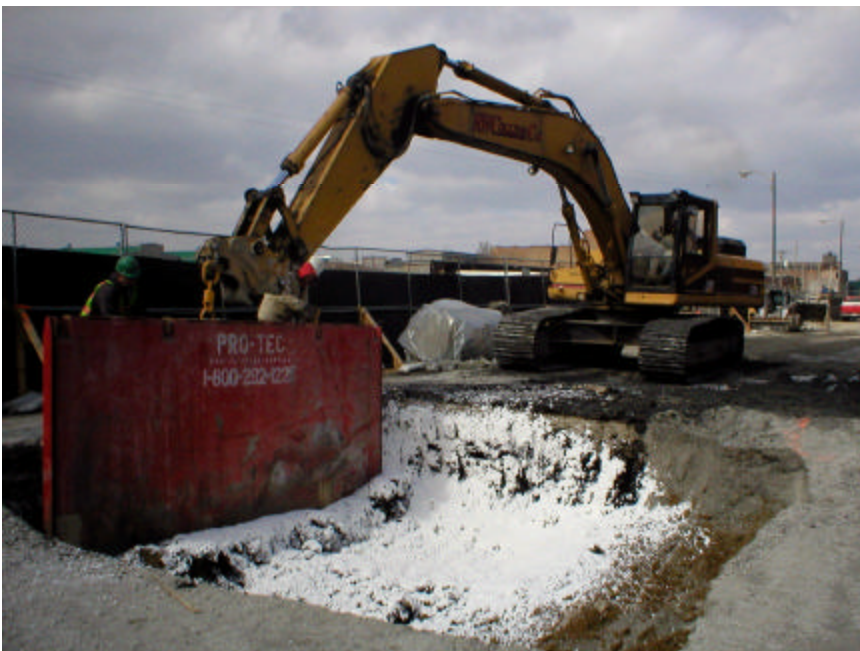
A Portion of Willow Street Station  
Date: March 21, 2003

View of foamed excavation in cell 6 lined prior to placement of shoring system.

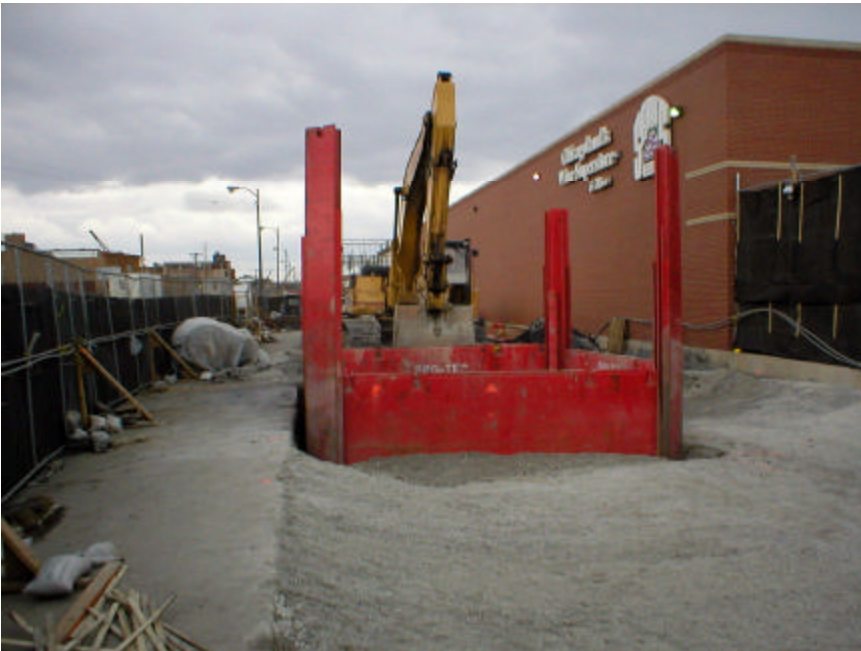
A Portion of Willow Street Station  
Date: March 21, 2003

View of shoring system installed in cell 6 prior to subsurface excavation.

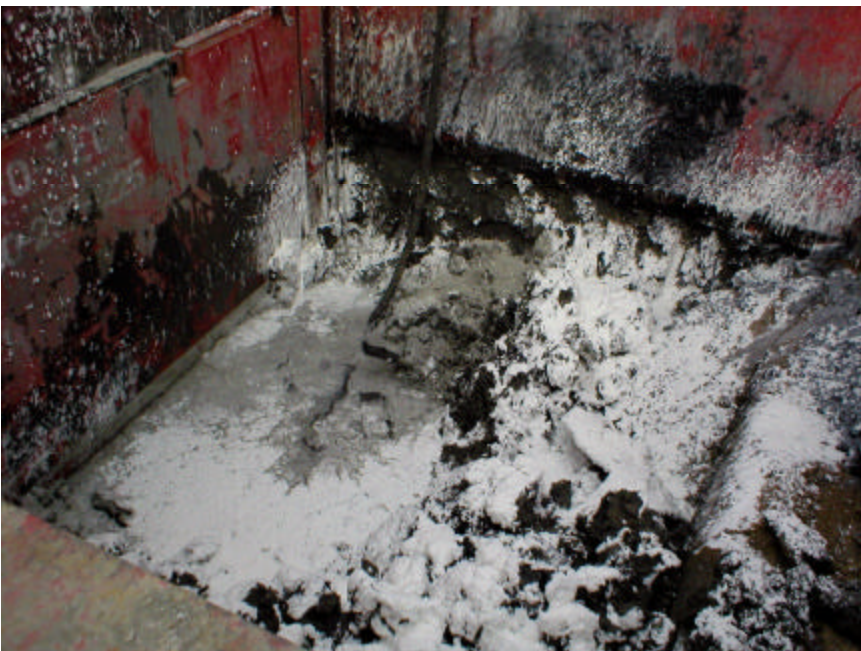
A Portion of Willow Street Station  
Date: March 24, 2003

View of foaming and dewatering of pipes inside cell 6.

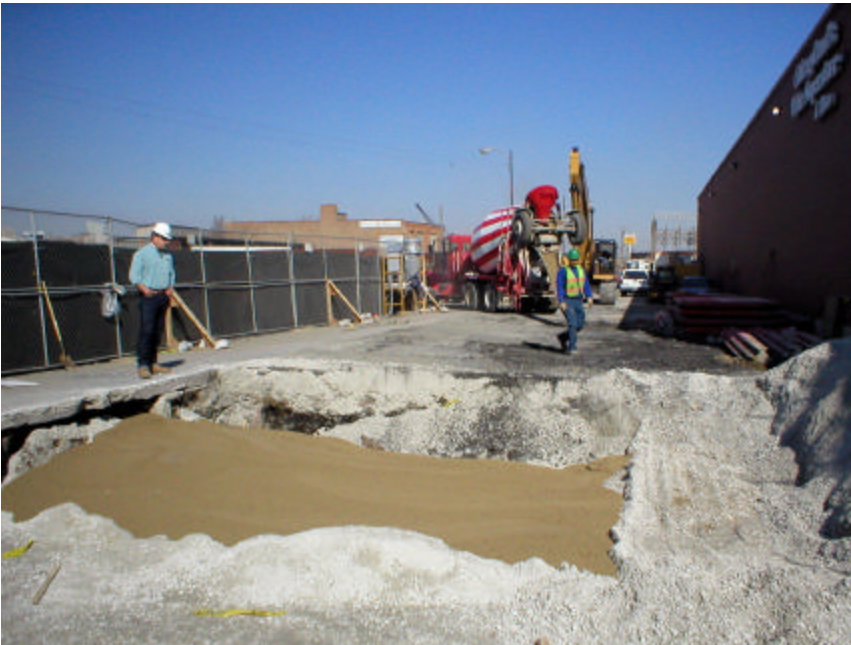
A Portion of Willow Street Station  
Date: March 31, 2003

View of cell 6 backfilled to 2 feet bgs following final flowable grout pour.

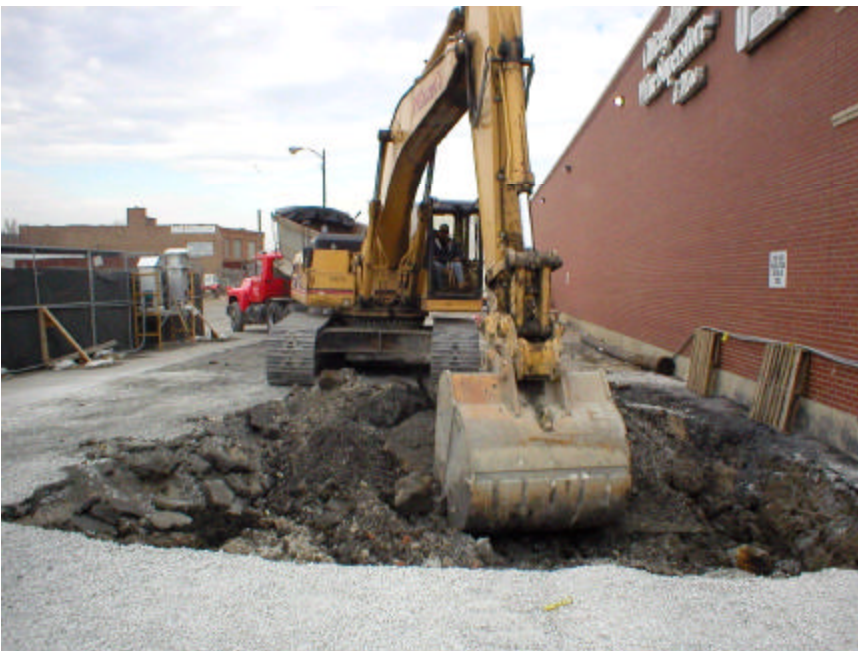
A Portion of Willow Street Station  
Date: April 1, 2003

View of excavation to 3 feet bgs north of cell 5.

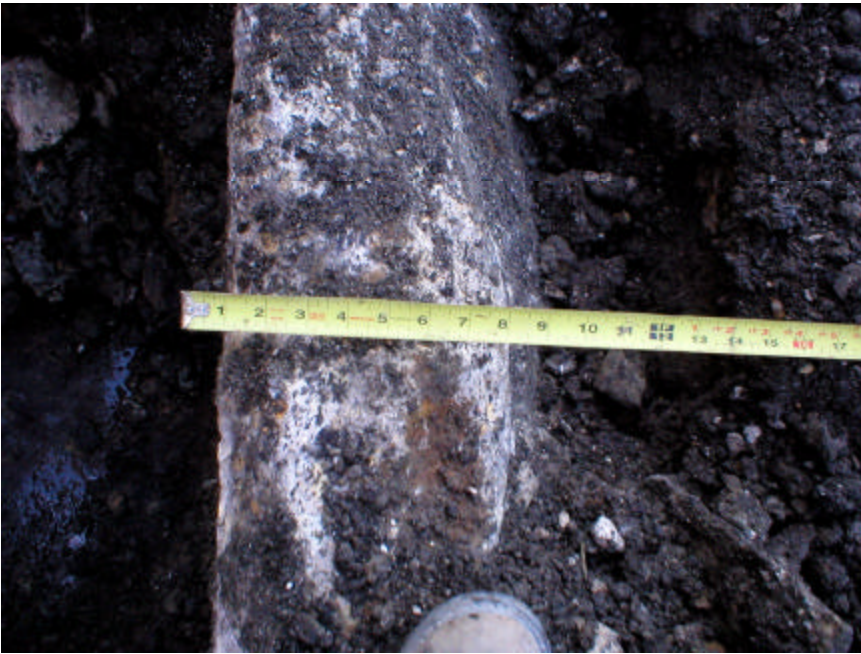
Date: April 2, 2003

View of concrete gas holder wall uncovered intact during excavation to 3 feet bgs north of cell 5.

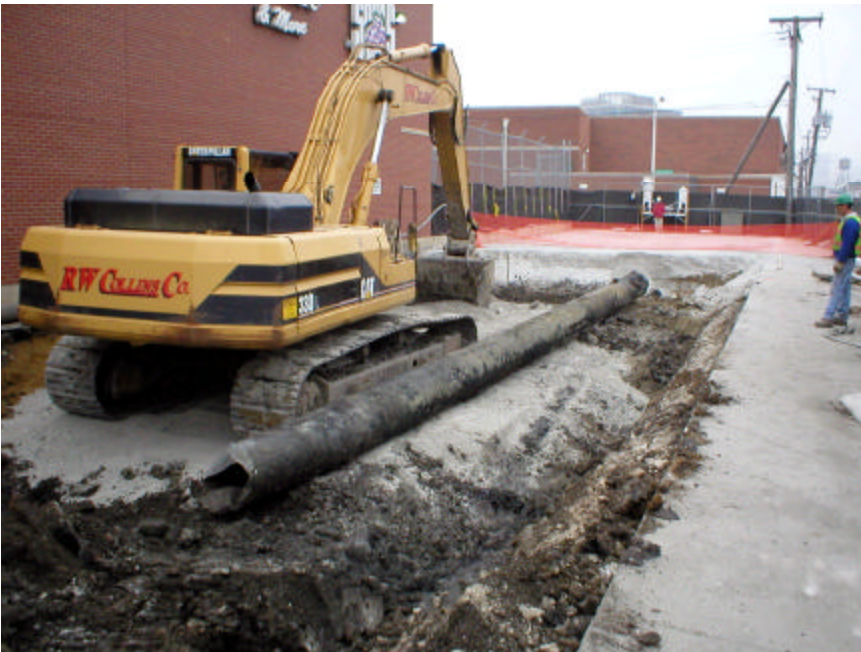
Date: April 3, 2003

View of abandoned pipe removed from along the sidewalk during 3-foot excavation.

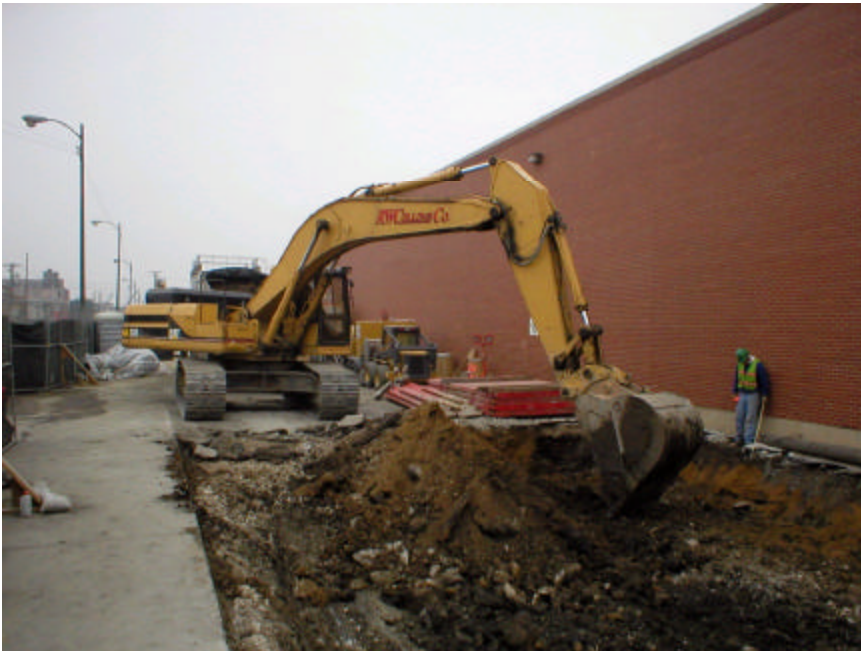
A Portion of Willow Street Station  
Date: April 3, 2003

View of 3-foot excavation north of source area removal.

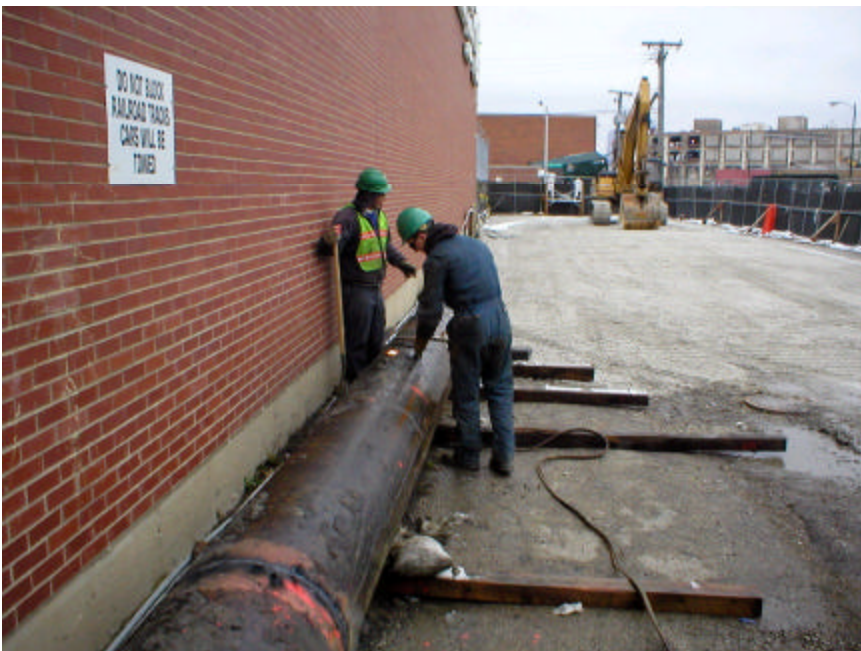
A Portion of Willow Street Station  
Date: April 8, 2003

View of site compacted to grade and abandoned pipe being cut for removal and disposal offsite.
